CITY OF BALTIMORE WET WEATHER CONSENT DECREE SMOKE AND DYED WATER TESTING FORM		Page 1 of 4
Sewershed: Low Level Subsewershed: 44	Company: REI/DRAYCO	Date: 09/02/2008
Test Type: Smoke	Ground Condition: Dry: X Damp: _ Wet: _	Supervisor: E.R. Crew: 04
Manhole ID: S17O__009MH	Test ID: 1029-588	Notifications Made: __X__ Residents, Fire, 311
Field Sketch: (Show all manholes with numbers, blower placement location, sandbag or isolation locations, street names, building addresses and locations, defect locations and photograph numbers)

CITY OF BALTIMORE
SMOKE TESTING OBSERVATION SUMMARY
LOW LEVEL SEWERSHED
BALTIMORE CITY PROJECT 1029
REI/DRAYCO

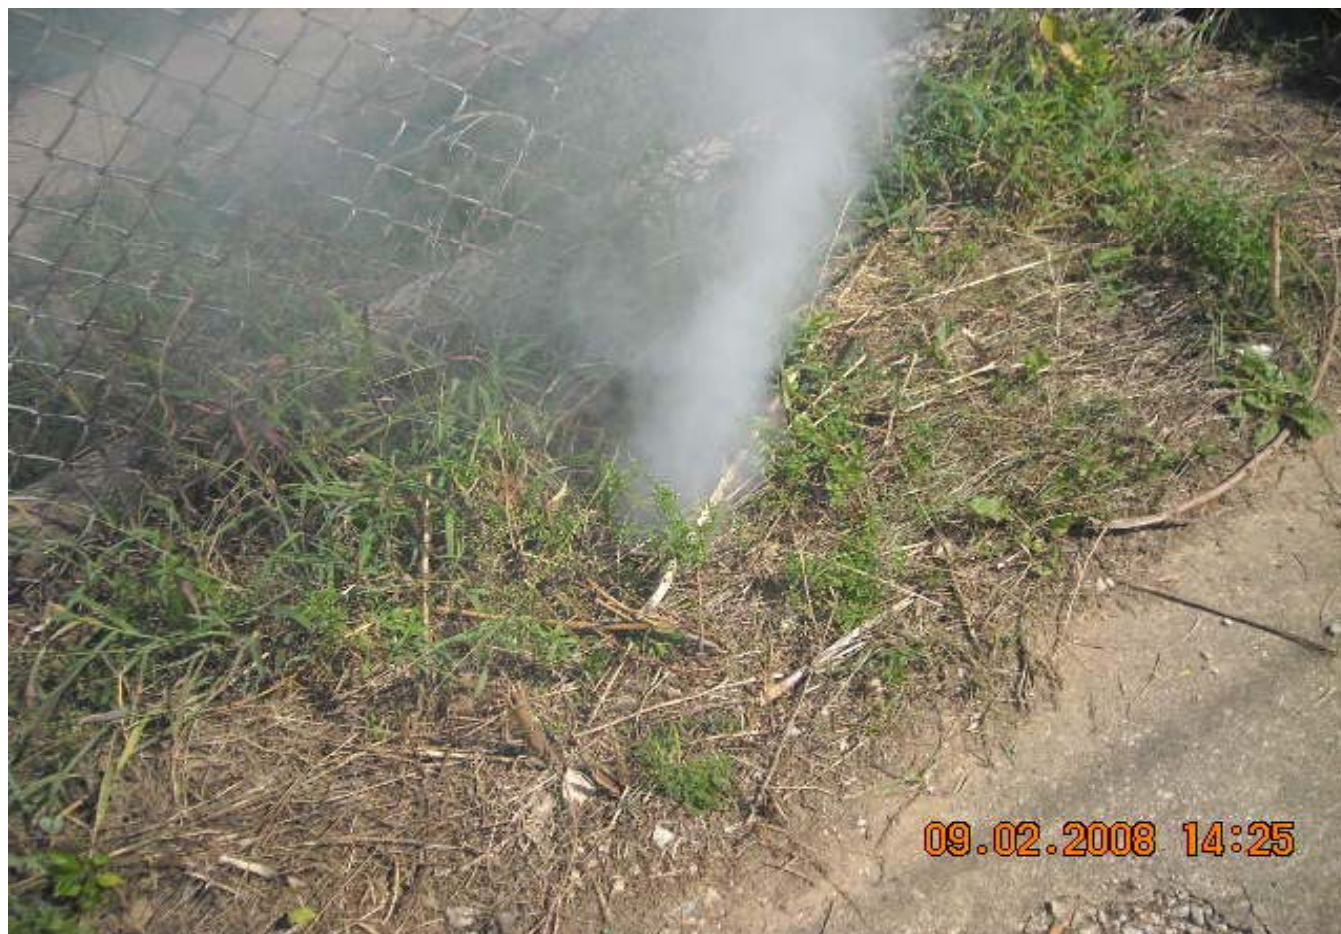
Photograph No: OB01-01
Filename: 1029-588_OB01-01.jpg

Unique Test ID: 588	Date: 09/02/2008	Basin: LL - 44	Manhole ID: S17O__009MH
Defect No: OB01	Supervisor: E.R.	Crew: 04	Dye Test Recommended: N
Location: 2418 CHRISTIAN ST.			
Source Type: 03 Cleanout		Sector: 02 Private	
Location: 08 Yard - Back		Severity: 03 Moderate	Drainage Area: 2
Comments: SMOKE IS COMING FROM THE BELOW GRADE CLEANOUT WITHOUT CAP.

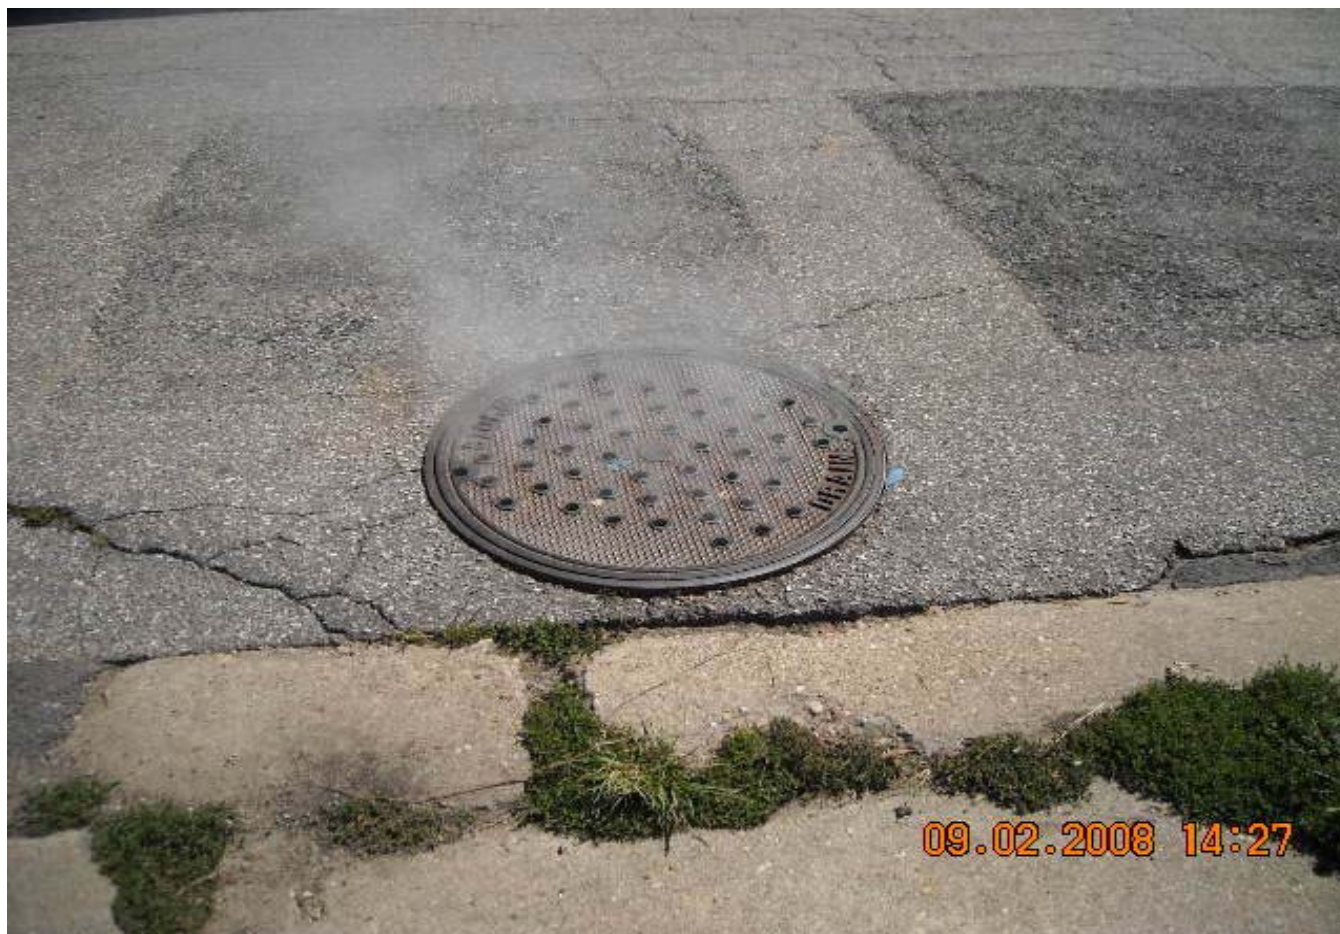
Photograph No: OB02-01
Filename: 1029-588_OB02-01.jpg

Unique Test ID: 588	Date: 09/02/2008	Basin: LL - 44	Manhole ID: S17O__009MH
Defect No: OB02	Supervisor: E.R.	Crew: 04	Dye Test Recommended: N
Location: S17O__027MH			
Source Type: 18 Other		Sector: 01 Public	
Location: 02 Asphalt		Severity: 03 Moderate	
Comments: MANHOLE S17O__027MH HAS A STORM DRAIN LID.		Drainage Area: 6
